Property Assessment Report
Westwood View Elementary School
2511 West 50th Street, Westwood, KS 66205

SHAWNEE MISSION SCHOOOL DISTRICT WESTWOOD VIEW ELEMENTARY SCHOOL BUILDING SUMMARY IMAGES

BUILDING SUMMARY REPORT

November 2017

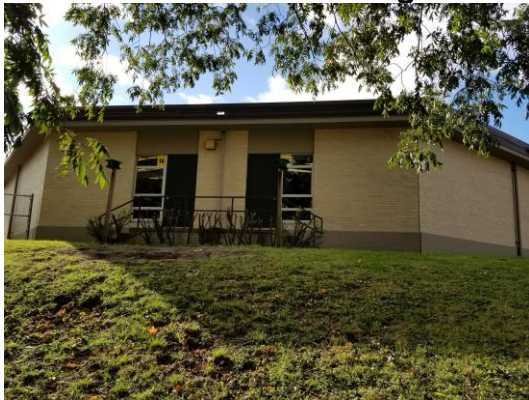
Facebrick and typical classroom exit

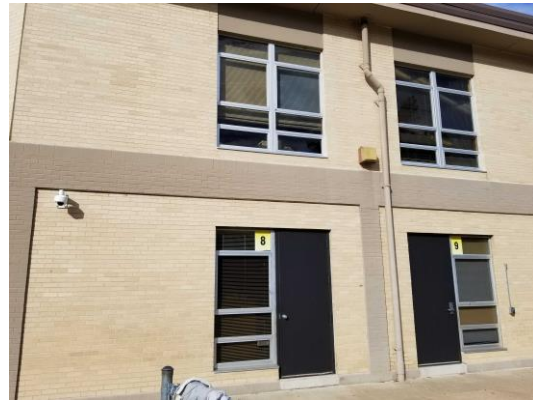
Typical exterior windows and doors

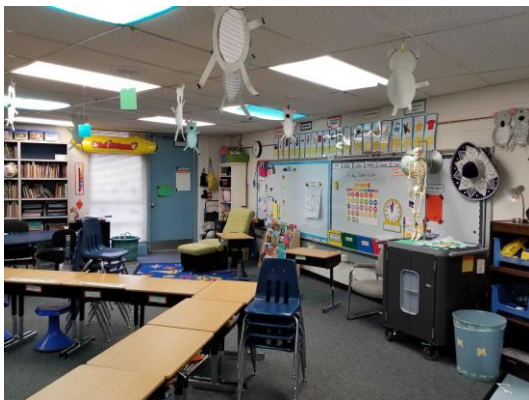
Typical classroom

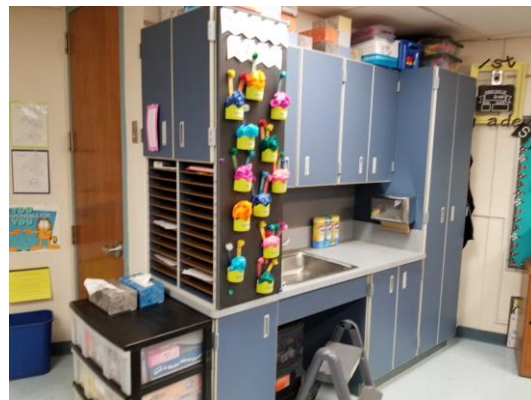
Classroom storage

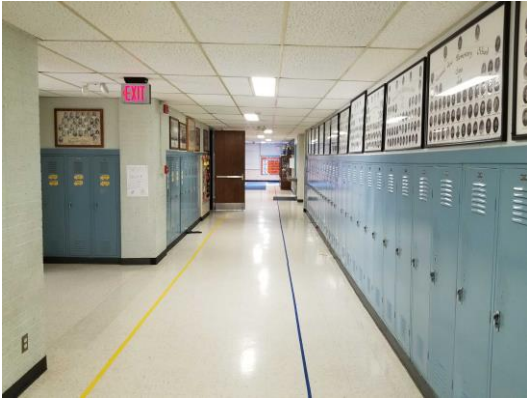
Corridor with VCT flooring

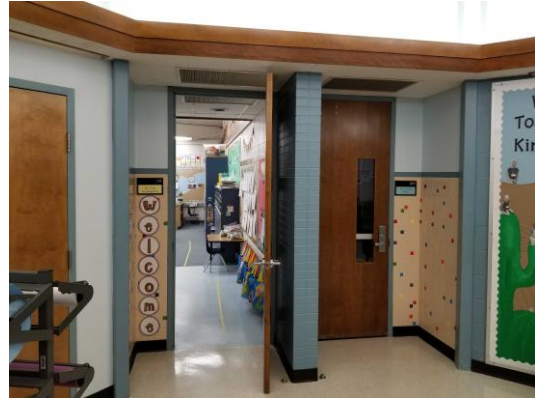
Classroom door recess

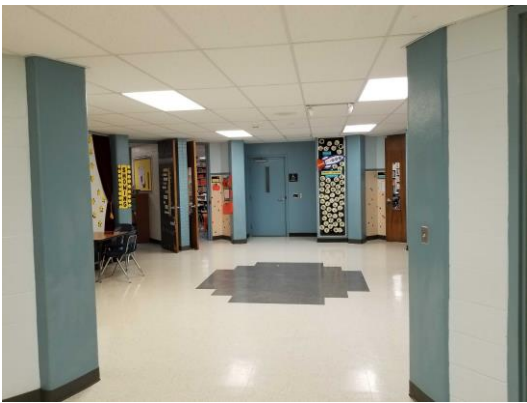
No egress at end of corridors

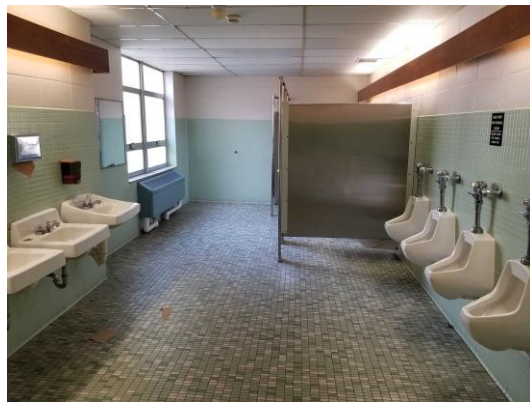
Typical restroom

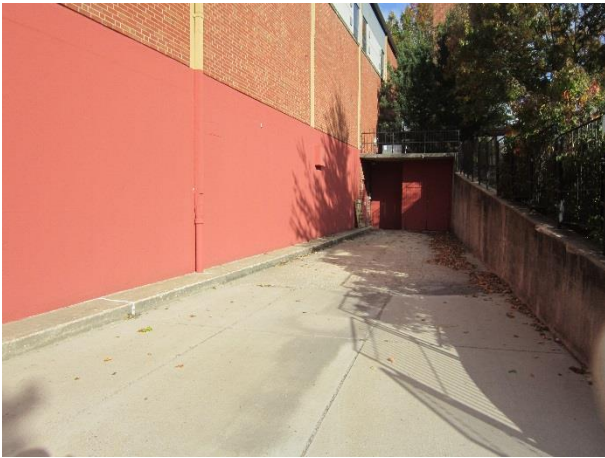
Additional exterior lighting recommended for security.

- Additional Updates required to bring systems up to current codes:
 - Electrical
 - All receptacles to be replaced with tamper resistant devices.
 - Additional Exterior lighting to ensure sufficient illumination.

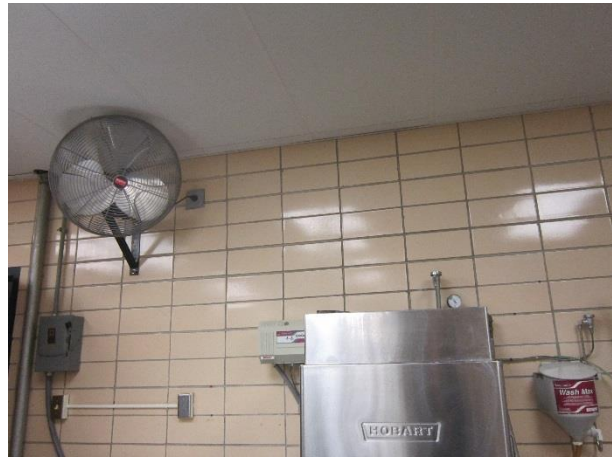
Dishwasher not vented.

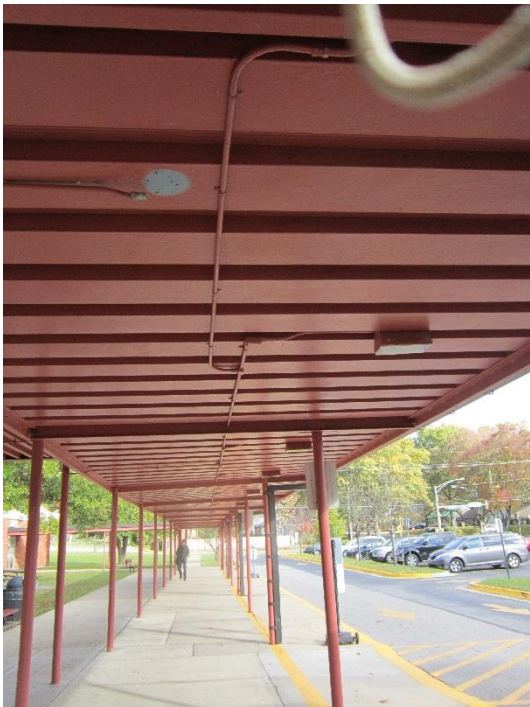
Exterior lighting in need of update & additional fixtures.

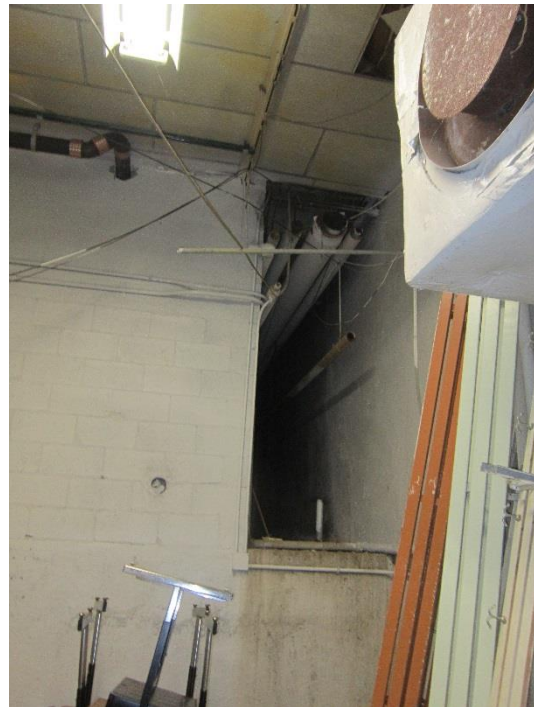
Original boiler & chiller system no longer in use.
