Property Assessment Report

Pawnee Elementary School

9501 West 91st Street, Overland Park, KS 66212

Hollis + Miller Architects

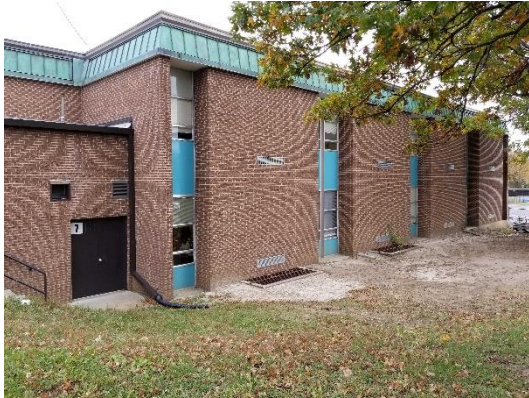
2 story classroom wing – erosion issues

- Potential drainage issues / erosion on west side of building.
- Lamb's tongue near roof line on west side of building.
- Majority of runoff appears to flow across the site to inlets on west side of property.
- Potential for storm water to overwhelm west storm sewer system.

Site Drainage Issues			\$275,000	\$68,750	\$343,750
	Restroom resinous floor recoating	3,500	\$8	\$28,000	\$7,000	\$35,000
	Add fire hydrants for adequate coverage			\$33,000	\$8,250	\$41,250
	Update HVAC systems – New Controls	61,691	\$2	\$123,382	\$30,846	\$154,228
	Eliminate corridor as return air path	61,691	\$2	\$92,537	\$23,134	\$115,671
	Drinking Fountain replacement			\$35,000	\$8,750	\$43,750
	Handwash Sink Mixing Valves			\$15,000	\$3,750	\$18,750
	Hot water recirculation line	61,691	\$0.45	\$27,761	\$6,940	\$34,701
	Insulate all water lines	61,691	\$0.35	\$21,592	\$5,398	\$26,990
	Sinks in each classroom	61,691	\$4.00	\$246,764	\$61,691	\$308,455
	Flush Valves and Faucets			\$12,000	\$3,000	\$15,000
	Add emergency boiler shutdown to existing boiler systems			\$12,000	\$3,000	\$15,000
	Install Fire Sprinkler System	61,691	\$4	\$246,764	\$61,691	\$308,455
	Exterior Lighting Upgrade	61,691	\$0.35	\$21,592	\$5,398	\$26,990

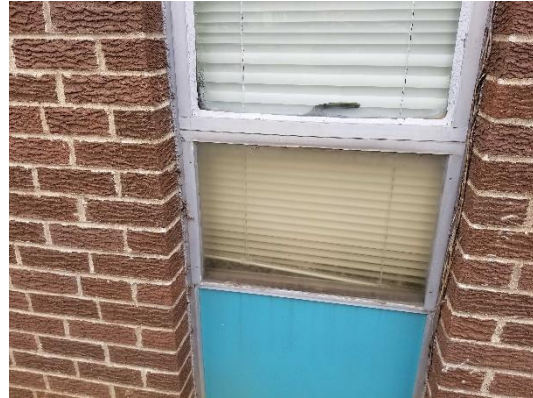
Typical exterior windows

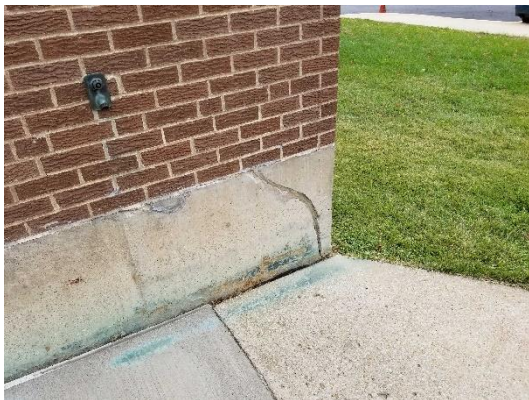
Damaged foundation wall

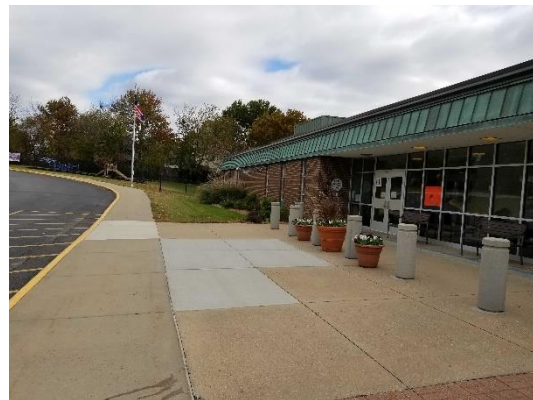
Recently repaired sidewalk

- Upper and lower parking lot asphalt needs replacing on west side of building.
- Sidewalk pitted on west side of building along parking lot.
- No concrete in dock area for trucks or dumpster.
- Dumpster not screened.
- Recycle bins (also not on concrete) in separate location.
- No apparent separation between bus / parent drop off.
- Bicycle parking not near building - a big hard surface area west of school near street.
- ADA parking in north parking lot not compliant.
- Tree roots buckling pavement in hard play area at NE corner
- No concrete pads under recycle bins. No concrete pads for trucks.

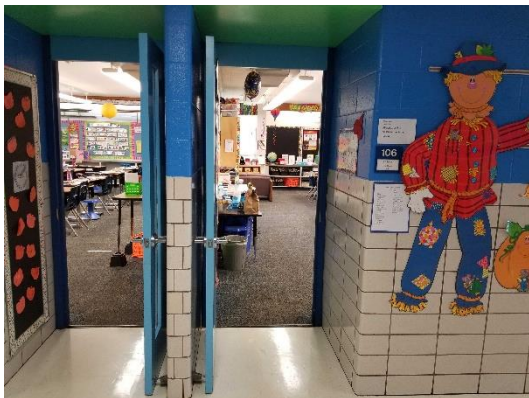
Classroom entry door recess

- Classrooms have a combination of VCT and carpet square floors, 12" x 12" ceiling tiles and suspended pendant lighting, exposed ductwork and painted CMU walls. Ceilings and lighting should be updated.
- Wood doors are painted with steel door frames and good hardware. Painted wood doors should be repainted with stain grade doors.
- Classroom doors open toward the corridor and are recessed to not encroach onto the corridor path of travel.
- Classroom door recess does not meet ADA clearance for a pull side approach. Door

recess need to be redesigned to meet ADA

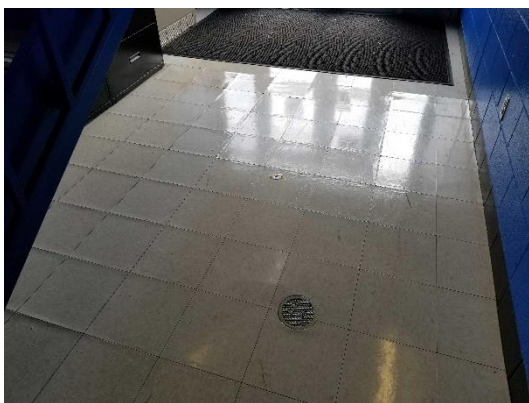
VCT flooring issue

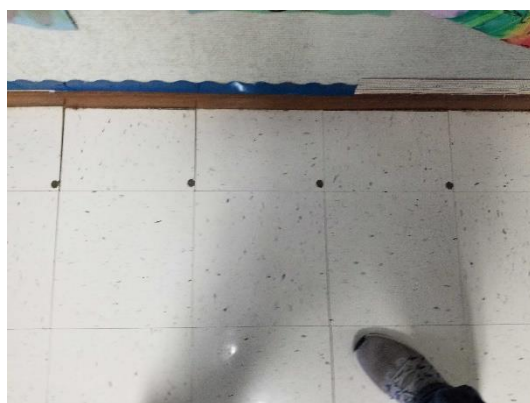
Mudjacking holes in corridor

- Corridors have VCT floors and gypsum board ceilings and surface mounted lighting and a glazed block wainscot and painted CMU walls
- Restrooms have resinous or welded seam sheet vinyl flooring, 12" x 12" acoustical ceiling tiles, surface mounted lights and glazed block walls. Recoat resinous flooring and replace ceiling tile
- Gymnasium has wood flooring, CMU walls, 12" x 12" ceiling tile with recessed lighting.
- Cafeteria has VCT flooring, CMU walls, exposed structure and wood fiber ceilings
- A 3,300 sf storm shelter was observed below the lower level.
- Several areas on the lower level have been mudjacked to correct settlement.

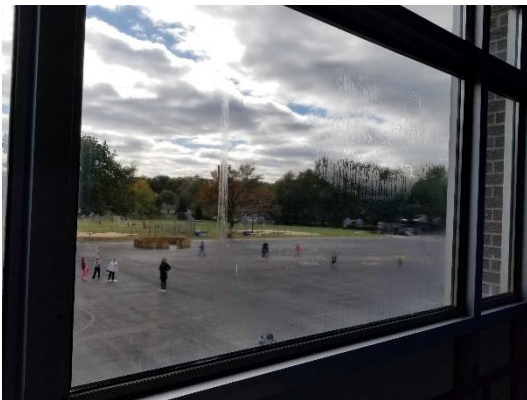
Storefront glass – loss of seal

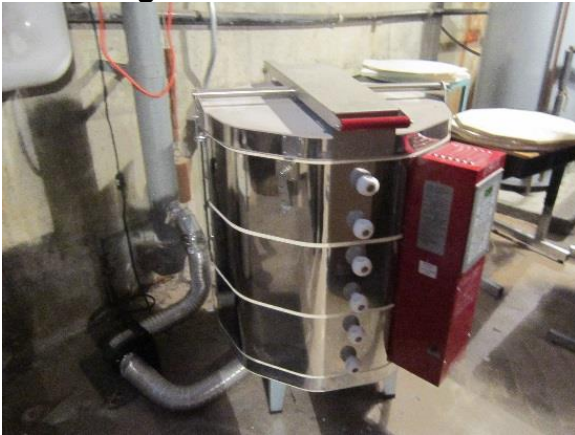
Art Kiln located in basement storage.

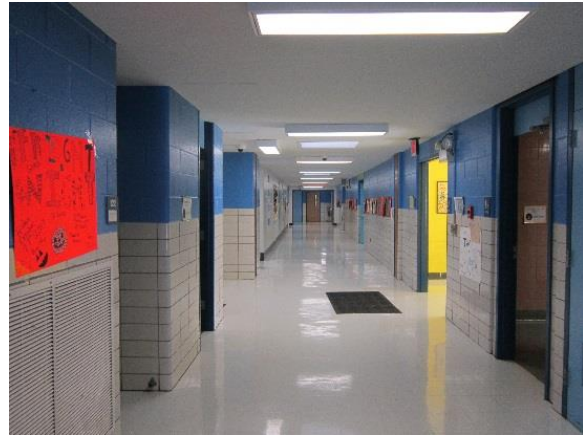
Corridor ceiling inaccessible.

- The majority of the existing building didn't have accessible ceilings. Piping, ductwork, conduits, and data cabling were installed exposed. All light fixtures were surface mounted. Existing ceiling heights are already low that adding drop in accessible ceiling to conceal all systems is not feasible.

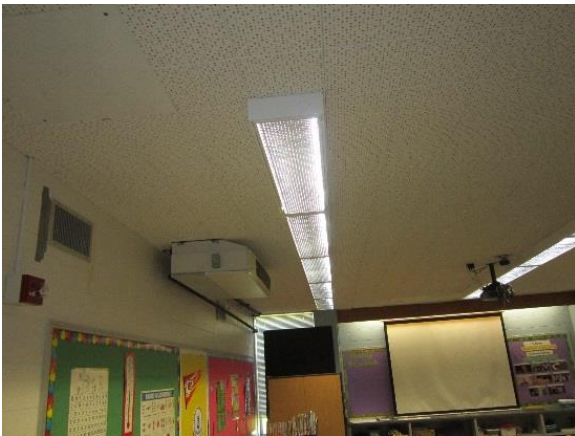
HVAC unit & piping exposed in classroom.

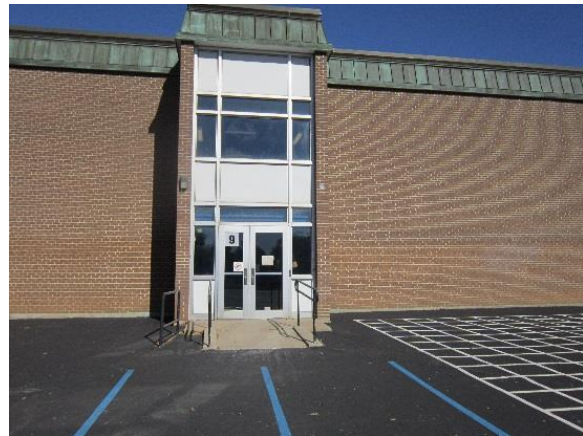
Lack of exterior emergency lighting.

- Electrical
 - All receptacles to be replaced with tamper resistant devices.
 - Additional Exterior lighting to ensure sufficient illumination.
 - Lighting

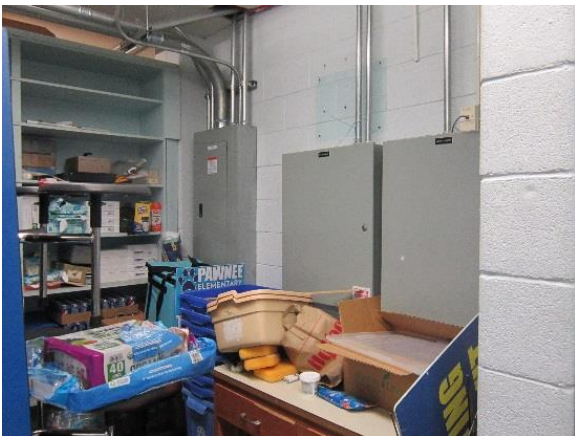
Lack of storage space from electrical equipment.

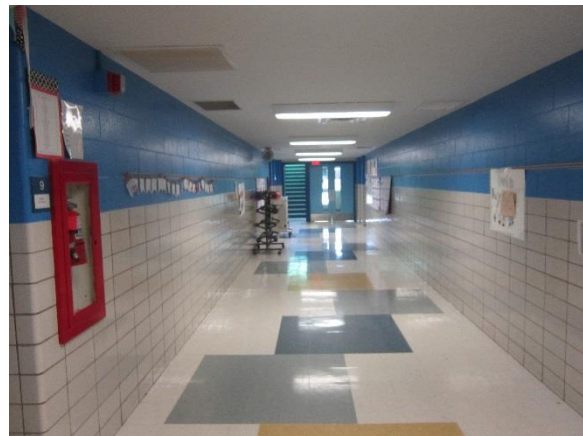
Limited emergency lighting visible in egress corridors.

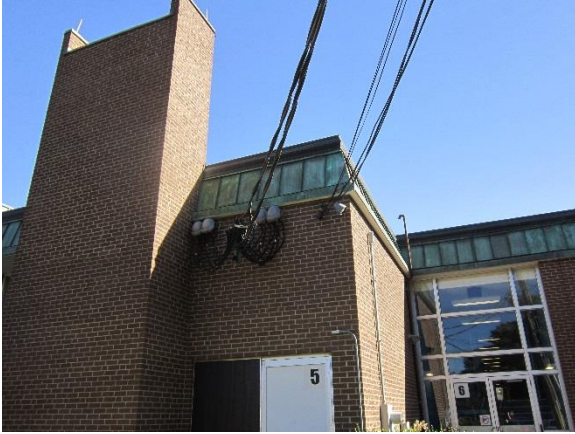
Overhead power service – main disconnect on storage platform inside mechanical room.

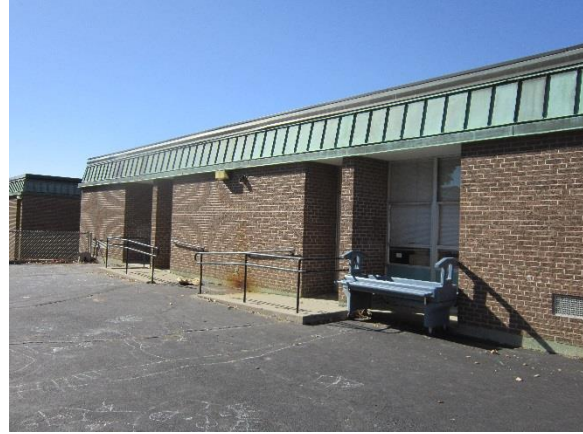
Roof drainage directly on sidewalk & discolored lightly.

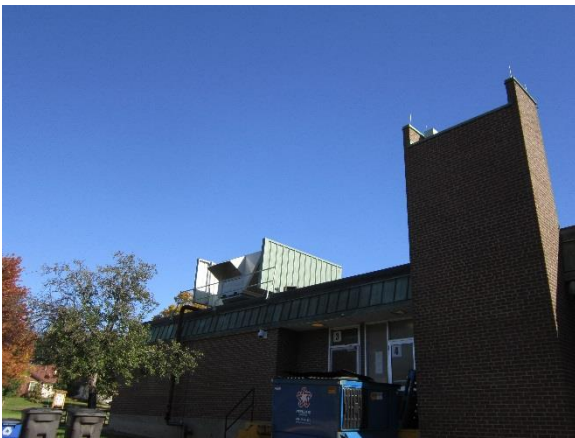
Rooftop unit with limited clearance to roof edge.

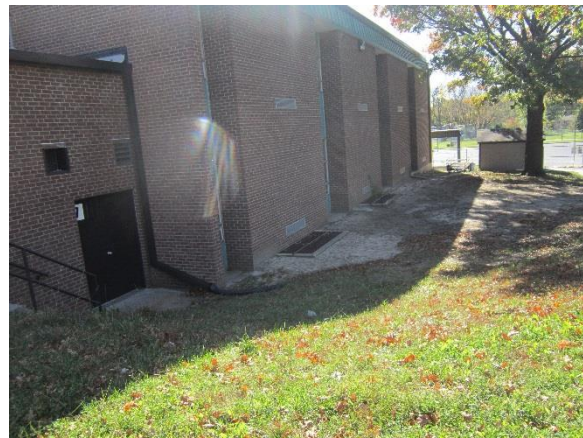
Storm shelter ventilation intakes located below grade.

- HVAC system serving Library space had loud rattle which could be disruptive to students and staff.
- Ventilation for basement storm shelter is below grade, during a major rain event a significant amount of water could infiltrate the basement if the ventilation louvers were opened.

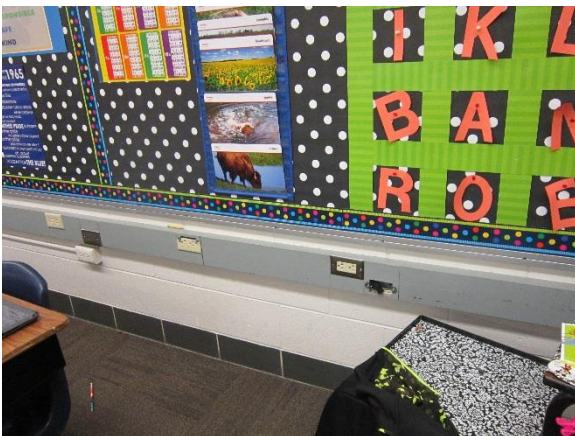
Surface raceway for outlets, devices damaged.

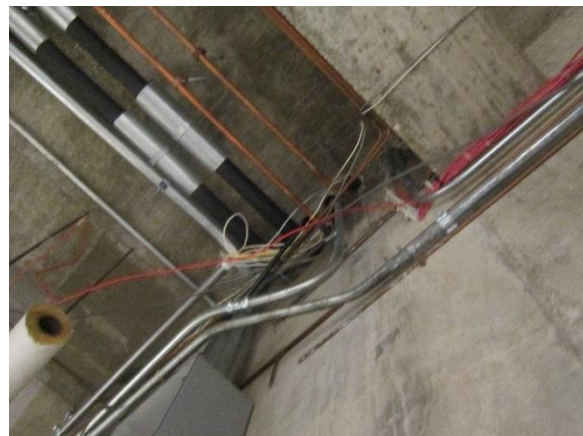
Uninsulated piping & cabling supported on pipes.

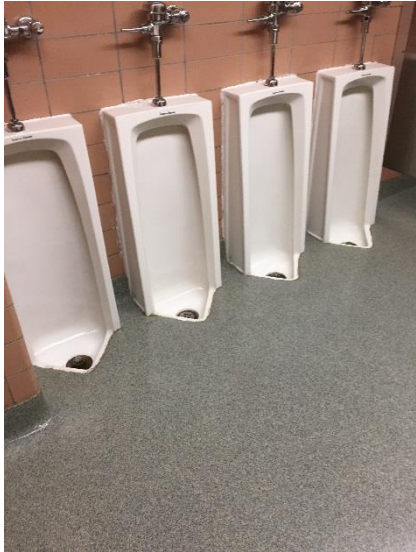
Floor mounted urinals.

- All handwashing sinks will need to have thermostat mixing valves installed to limit maximum water hot water temperature to 110°F.
 - Replace floor mounted urinals with wall mounted urinals.

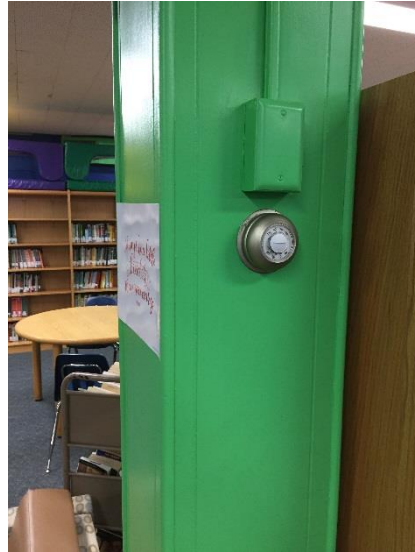
No humidistat for humidity control.

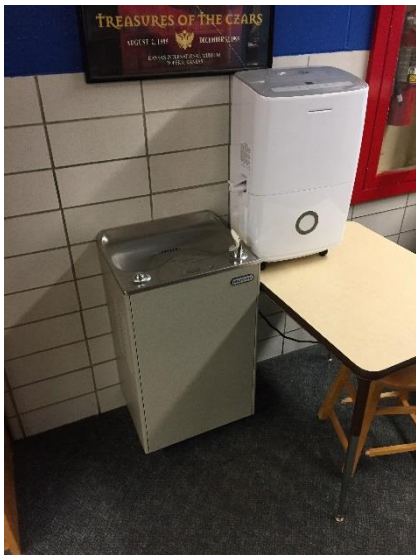
Portable dehumidification unit.

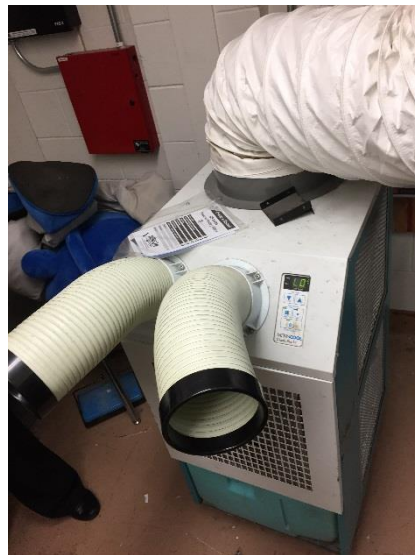
Portable air-conditioner for data rack.

- Data closet has a portable air conditioner being used as main condition of space.
- Corridor seems to be a path for some of the return air, which does not meet current code requirements.
