Property Assessment Report
Shawnee Mission West High School
8800 W 85th St, Overland Park, KS 66212

ROOF ASSESSMENT

SHAWNEE MISSION SCHOOL DISTRICT
SHAWNEE MISSION WEST HIGH SCHOOL
BUILDING SUMMARY IMAGES
December 2018

SHAWNEE MISSION SCHOOL DISTRICT SHAWNEE MISSION WEST HIGH SCHOOL BUILDING SUMMARY REPORT

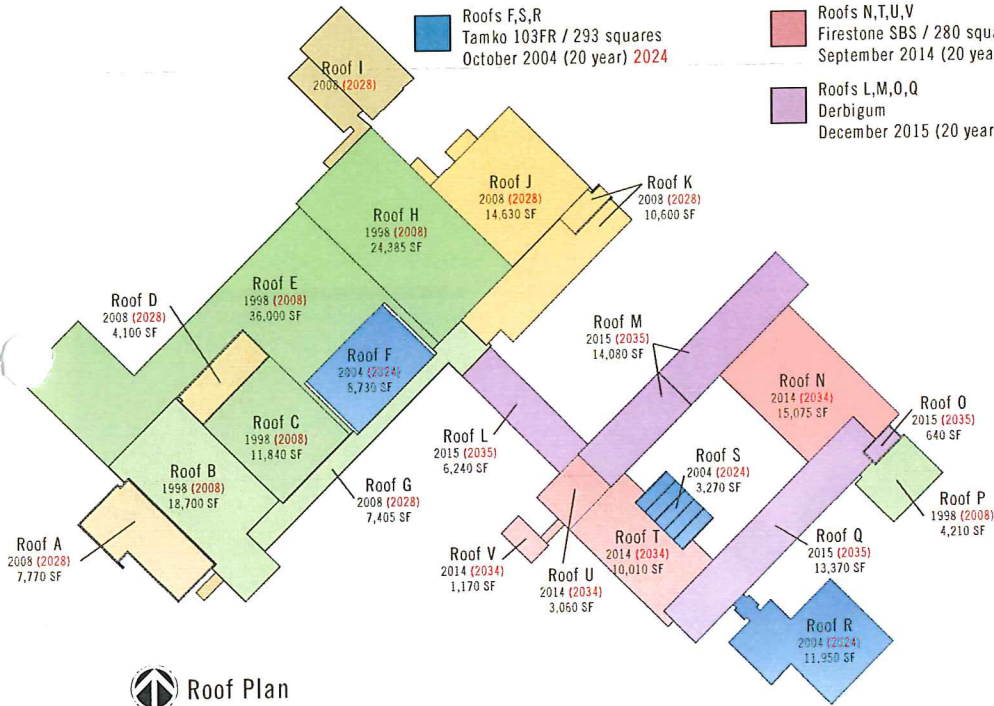
Roofs B,C,E,G,H,P
 Tamko 103 / 1232 sq.
 November 1998 (10* year) **2018**

Roofs F,S,R
 Tamko 103FR / 293 squares
 October 2004 (20 year) **2024**

Roofs A,D,I,J,K
 Tamko 109FR / 465 squares
 October 2008 (20 year) **2028**

Roofs N,T,U,V
 Firestone SBS / 280 squares
 September 2014 (20 year) **2034**

Roofs L,M,O,Q
 Derbigum
 December 2015 (20 year) **2035**

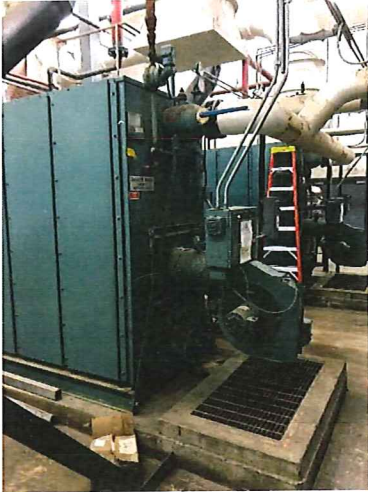
Boiler

- Pool unit is more than 20 years old. Typical life span is 15 – 20 years.
- Boilers more than 20 years old. Typical life span is 20-25 years.
- Multizone air handlers are an inefficient mechanical system.

- Boilers are not high efficient type.
- Building has operable windows. Operable windows make it difficult to maintain humidity levels within the building.

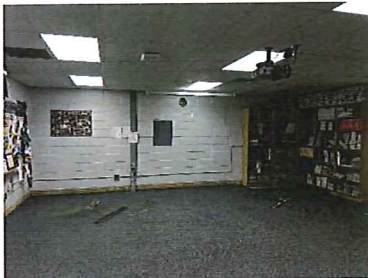
Electrical Panel in Classroom

- Electrical panel was observed being located in classroom. Not the most convenient location for a electrical panel.
- Special Systems (Fire Alarm, Intercom, Data Systems)

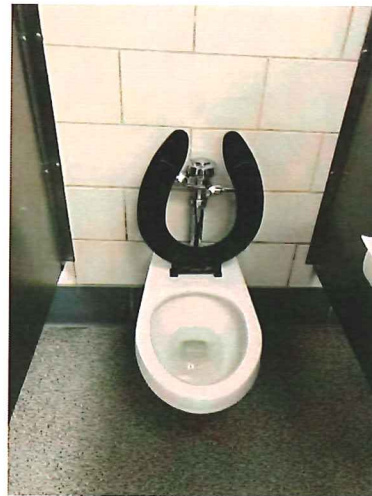
Plumbing Fixture

- Portions of building have internal overflow drains and other portions don't have any overflow drains.
- The majority of the restroom groups appeared to have not been updated to Shawnee Mission School District standard faucets, flush valves, china, etc.

- Additional Updates required to bring systems up to current SMSD Standards:
 - Replace all faucets and flush valves with Toto sensor devices.
 - Hot water recirculation line shall tie into hot water line with-in 3 feet of every hand washing sink.

- Replace majority of water closets and urinals with new wall-mounted fixtures.

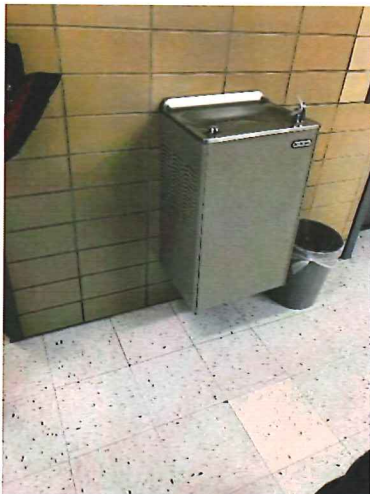
Water Cooler

- Some areas of building had water coolers that were ADA compliant and had bottle fillers and the other areas didn't have ADA compliant and bottle filling water coolers.
