Property Assessment Report
Shawnee Mission West High School
8800 W 85th St, Overland Park, KS 66212

ROOF ASSESSMENT

SHAWNEE MISSION SCHOOL DISTRICT
SHAWNEE MISSION WEST HIGH SCHOOL
BUILDING SUMMARY IMAGES
December 2018

SHAWNEE MISSION SCHOOL DISTRICT SHAWNEE MISSION WEST HIGH SCHOOL BUILDING SUMMARY REPORT

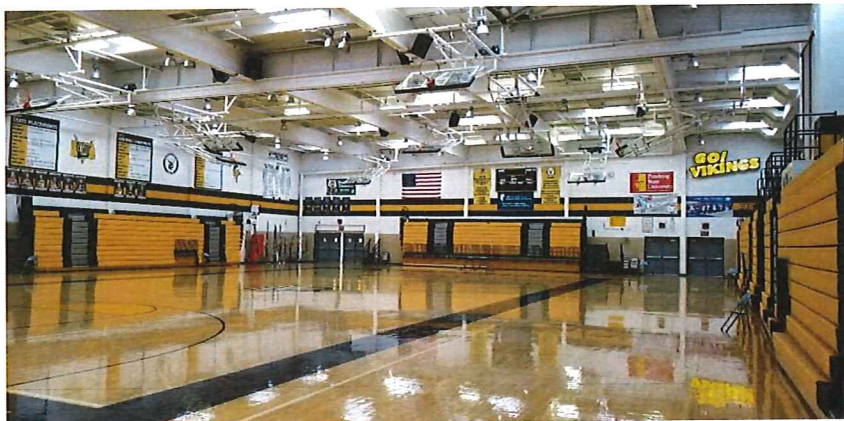
- Gymnasium has wood flooring, CMU walls and the ceiling is open to structure
- Cafeteria has VCT flooring, plaster walls, 2'x4' ceiling tiles and recess lighting, all in good condition.

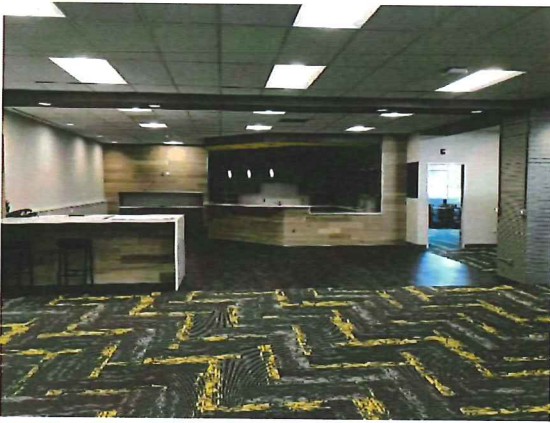
- Media Center was renovated in 2018 and in good condition.
